INDOOR AIR QUALITY ASSESSMENT

**PACE Head Start Program
T.A. Green Building
32 Madison Street
New Bedford, Massachusetts**

Prepared by:
Massachusetts Department of Public Health
Bureau of Environmental Health Assessment
Emergency Response/Indoor Air Quality Program
January 2004

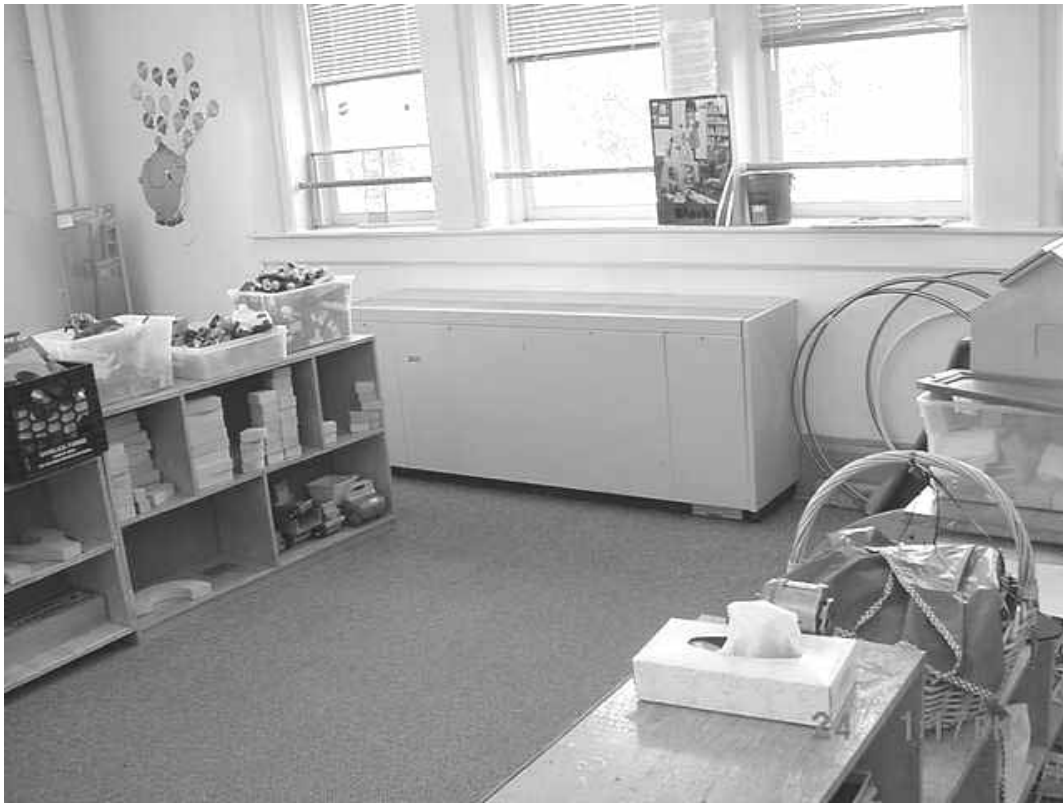
Picture 1

Fresh air in classrooms is supplied by a unit ventilator (univent) system ([Picture 1](#)). Univents draw air from outdoors through a fresh air intake located on the exterior walls of the building (Picture 2) and return air through an air intake located at the base of each unit (Figure 1). Fresh and return air are mixed, filtered, heated or cooled and provided to classrooms through an air diffuser located in the top of the unit. Adjustable louvers control the ratio of outside to recirculated air. As discussed, univents were deactivated in classrooms throughout the building preventing the introduction of fresh air. In order for univents to provide fresh air as designed, these units must remain “on” and allowed to operate while rooms are occupied. In addition, air diffusers and return vents must remain free of obstructions.

Typical Classroom Univent

6. Remove all blockages from univents and exhaust vents to ensure adequate airflow.

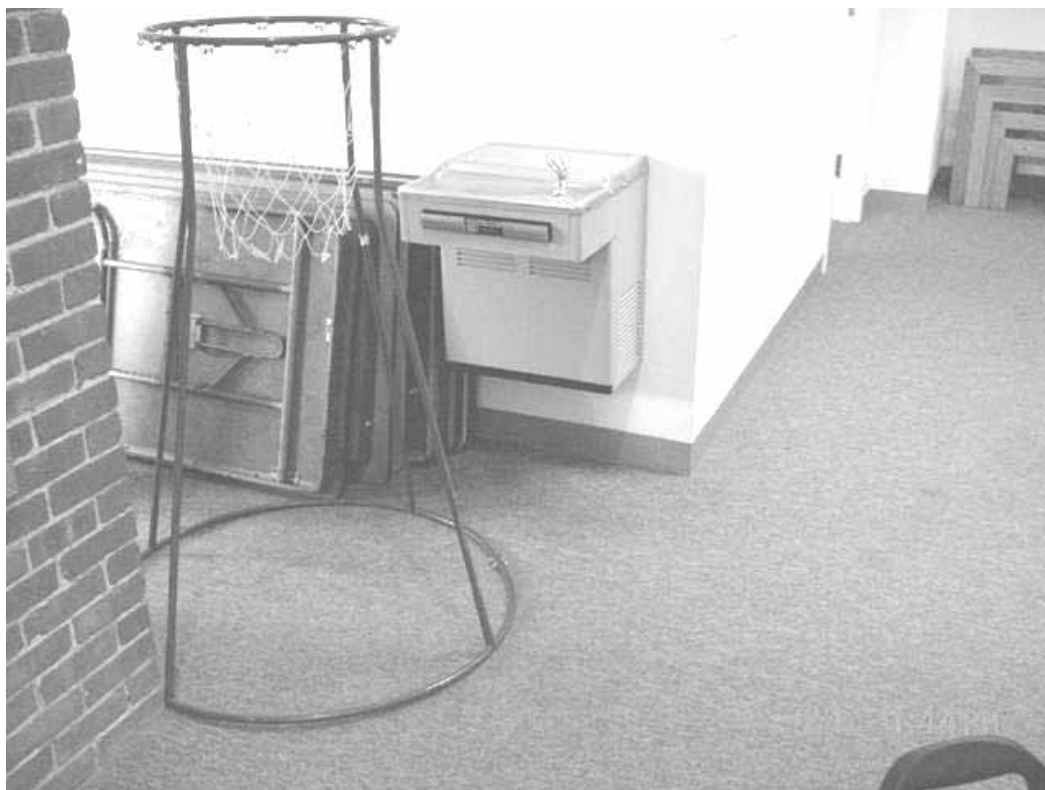
Picture 5

Water coolers and water fountains were installed over carpeting (Pictures 5 & 6). Spills from water coolers/fountains can result in wetting of the carpet, which can lead to mold growth especially if wetted repeatedly.

Water Fountain Over Carpeting

10. Install a water impermeable barrier (e.g., rubber/plastic) beneath water fountains/coolers to prevent water damage/mold growth to carpeting.
11. Clean exhaust/return vents periodically to prevent excessive dust build-up.

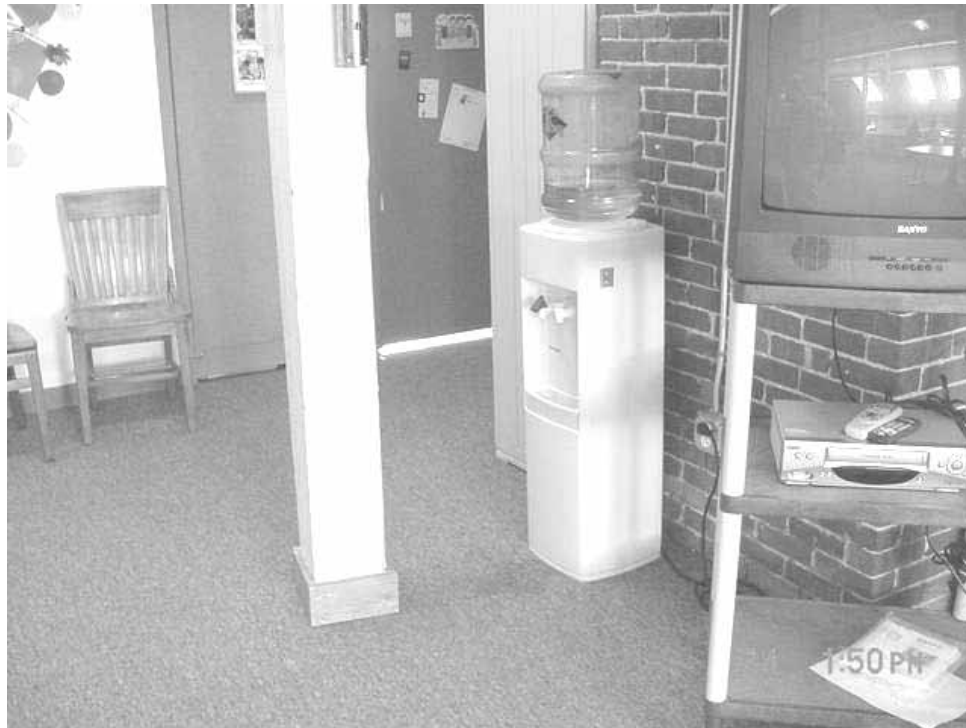
Picture 6

Water Cooler on Carpeting

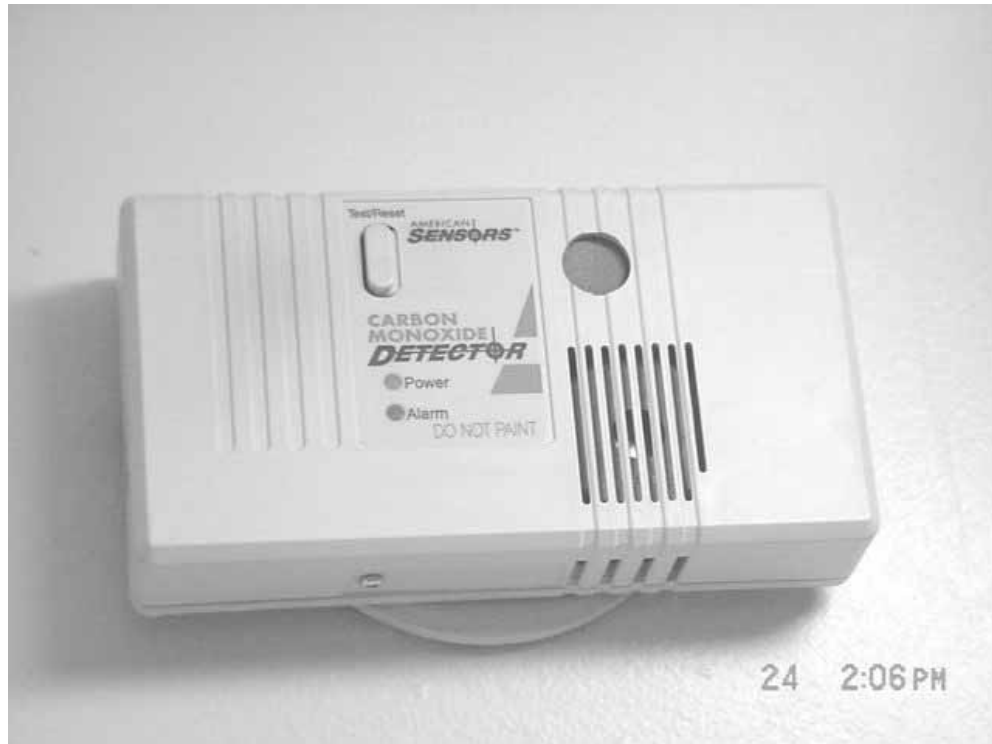
Picture 7

Several measures were reportedly taken to address water heater exhaust odor within the building. The water heater was professionally serviced and the exhaust ventilation improved. In addition, a portable carbon monoxide (CO) detector was installed in the hallway outside the boiler room (Picture 7). This monitor is not equipped with a digital readout but is designed to sound an alarm when CO concentrations reach a certain pre-programmed level.

Wall-Mounted Carbon Monoxide Detector

2. Consider using a carbon monoxide detector with a digital readout in place of the alarm only model in the basement.
3. Keep exterior doors to boiler room shut and seal utility holes and other potential pathways for air to migrate into adjacent areas.

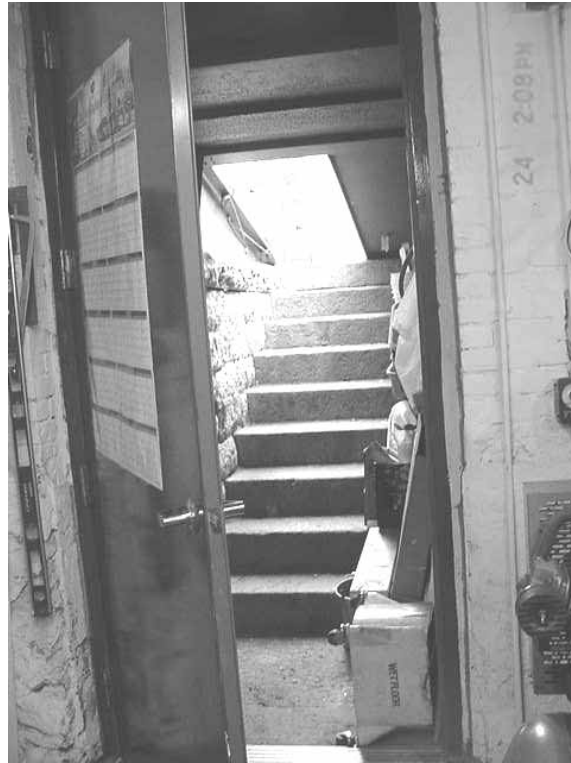
Picture 8

The bulkhead door to the boiler room was open during the assessment (Picture 8). The production of exhaust emissions in combination with cold air moving from outdoors through open exterior doors can pressurize the boiler room. Positive pressure within a room will force air and pollutants through spaces around doors, utility pipes and other holes in walls, doors and ceilings (Picture 9). To reduce airflow into the adjacent areas, sealing of these potential pathways should be considered.

Open Bulkhead and Entrance to Boiler Room

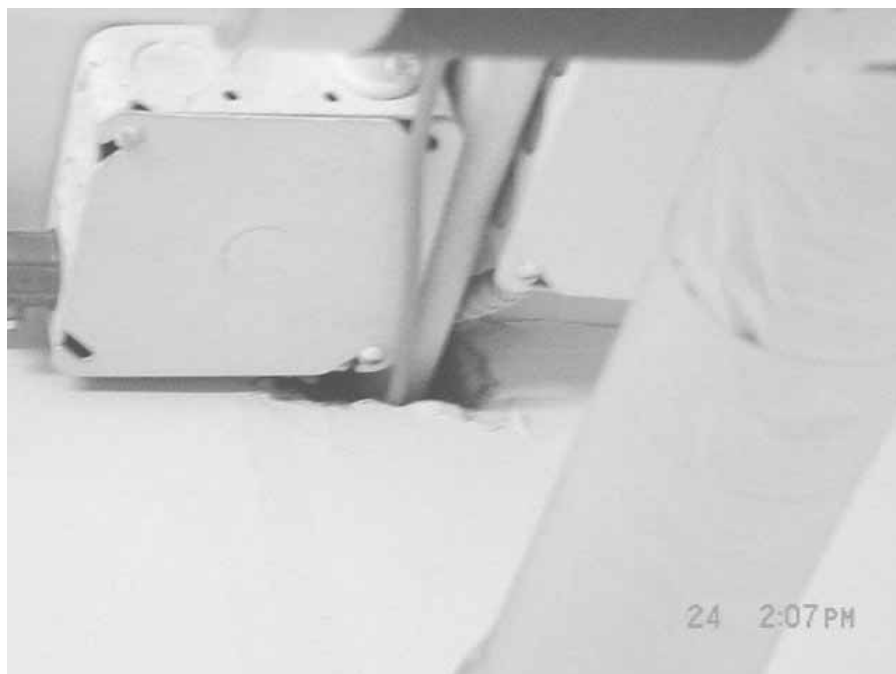
Picture 9

Open Utility Hole in Boiler Room
